# My 1910 Buick

## Model 17

### Rear End Rebuild

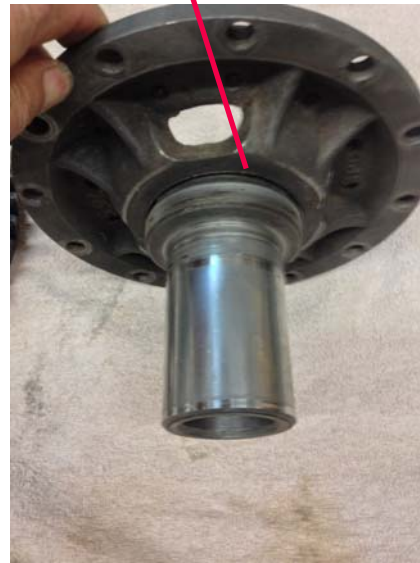
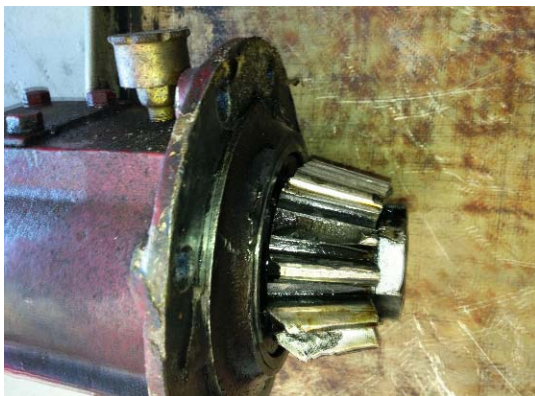
Once again I called upon the assistance of my brother Peter and friend Paul Carter (and his shop) to help me with the repair. Together we removed the rear end from the car and took it apart. The picture below will show you part of what we found, the pinion

had several teeth missing, the majority of the Hyatt bearings were worn out but the most troubling thing was that the crown gear half of the carrier was broken. If you look carefully at the picture below you will see a major break at the base of the thread.

*The first thing we saw when the rear end came apart*

What to do? Contact Skip Carpenter of course! I called Skip and told him about the broken crown gear half of the carrier. He immediately said "not to worry" they all break. He put me in touch with Bruce Zillmer who had a pattern to recast these carriers. I contacted Bruce and he said he would send his pattern to Skip who agreed to have one cast for me at the very modest price of \$85.00. Skip also told me that Doug Layport, the same machinist who did the major part of the machining of my replacement crankcase, was jugged up to machine these carriers.

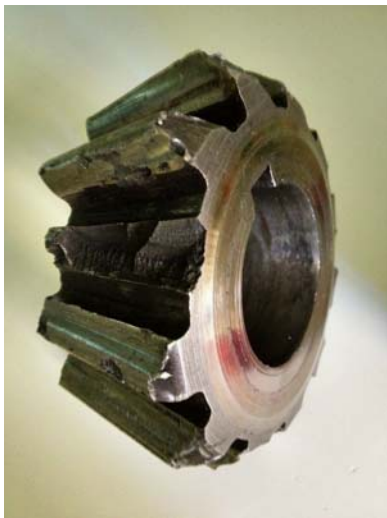
*Broken Pinion*  
*Not very pretty!*

With the rear end fully assembled, it was now time to put it in the car and go for a test drive. What a treat that was! The car ran smoother and quieter than it ever has - it didn't even sound or drive like my car! There is no doubt that this rear end had been failing for quite some time and, I suspect, the carrier was the first thing to break which resulted in an extreme amount of backlash with the resulting failure of the pinion.

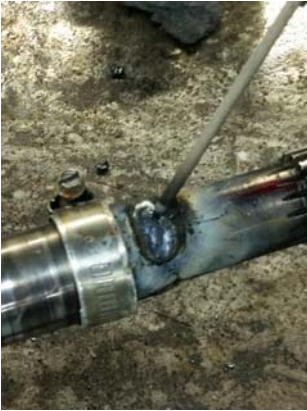
Drive shaft straightening

While the casting of the carrier and it's subsequent machining was being done we put our minds to dealing with the above issues. To straighten the drive shaft we ran several beads of arc weld to the shaft hoping that when the metal cooled and shrank it would pull the shaft straight. We were lucky because after the first weld had cooled the shaft improved from being 25 thou. bent to only 7 thou.. What to do about this 7 thou. you might ask? Well the answer was to take the drive shaft to my friend Barry Rutherford, the owner of Shadbolt Cams, and ask him for his advice. He simply placed it in his cam straightening machine and after a few raps with "Arnold" (his name for a large impact hammer) the drive shaft was only 2 thou. out which we all felt was acceptable.

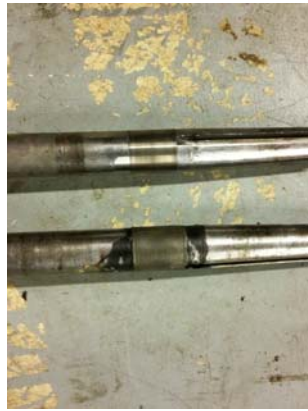
Axle spray welding to fit new style bearings. Bottom axle before grinding and the top one is after

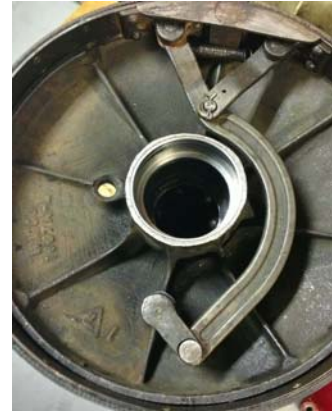
Stepped sleeve for new style wheel bearing

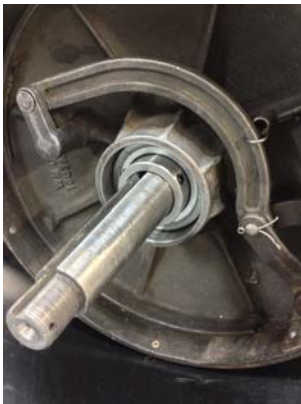
New style Lock Collar Ball wheel bearing

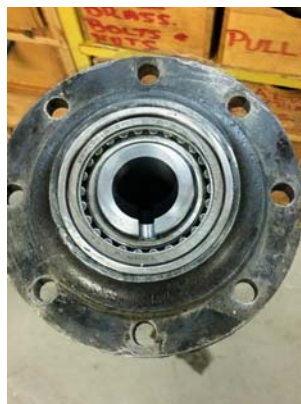
Torrington pinion bearings with new sleeve installed

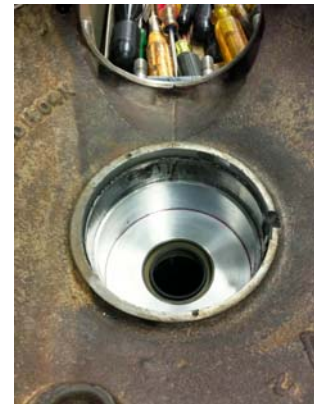
Stop for Timken cup and new seal and plate

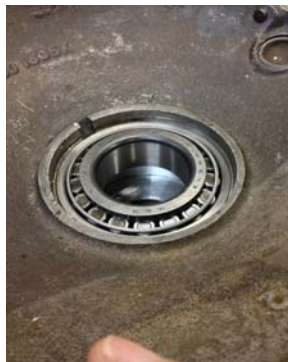
Timken bearing in rear end housing

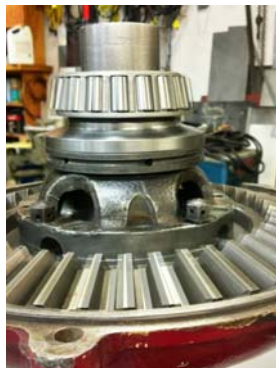
Spacer to replace original ball thrusts seen just below Timken bearing

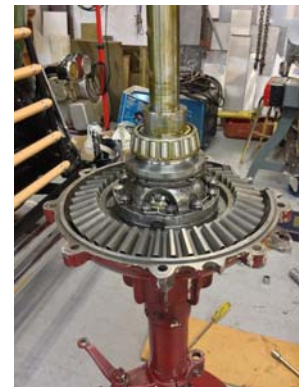
Rear end being assembled

Once all of the above and other repairs too numerous to describe, were complete I was ready to start the reassembly. My goal was to set the gear backlash between 4 & 8 thou. and the carrier bearing pre-load at between 7 and 15 inch pounds. I can happily report that both these goals were accomplished.

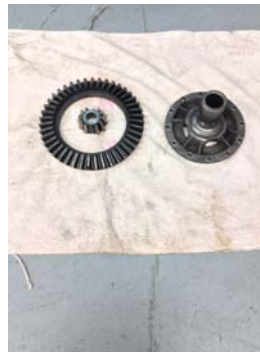
Crown, pinion and crown gear half of the carrier

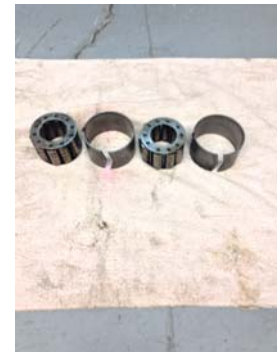
Carrier Hyatt bearings which were replaced by Timken ones

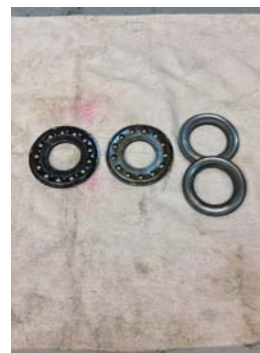
Carrier thrust bearings, also replaced by the Timken bearings

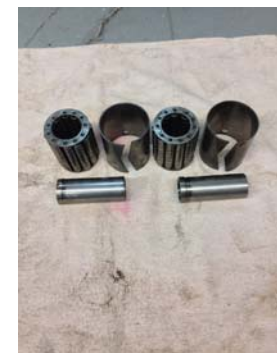
Wheel bearings which were replaced by the Lock Collar Ball bearings

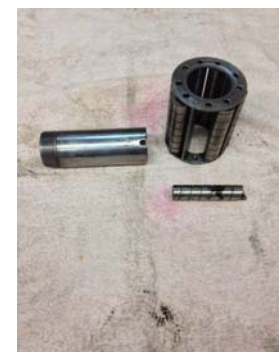
Pinion bearing and sleeve which were replaced by Torrington ones with a new sleeve

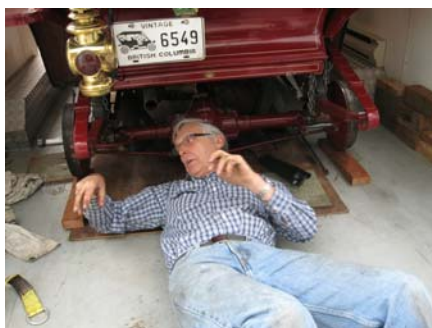
Being installed
